## INITIAL SITE INVESTIGATION

SMS Site #94-1723  
UST Facility #4763194  
TSEC #94-171

**RE: INITIAL SITE INVESTIGATION REPORT  
Calder & Richardson, Bulk Storage Facility  
Mill Street, Barre, Vermont  
VT SMS Site #94-1723  
TSEC Project #94-167**

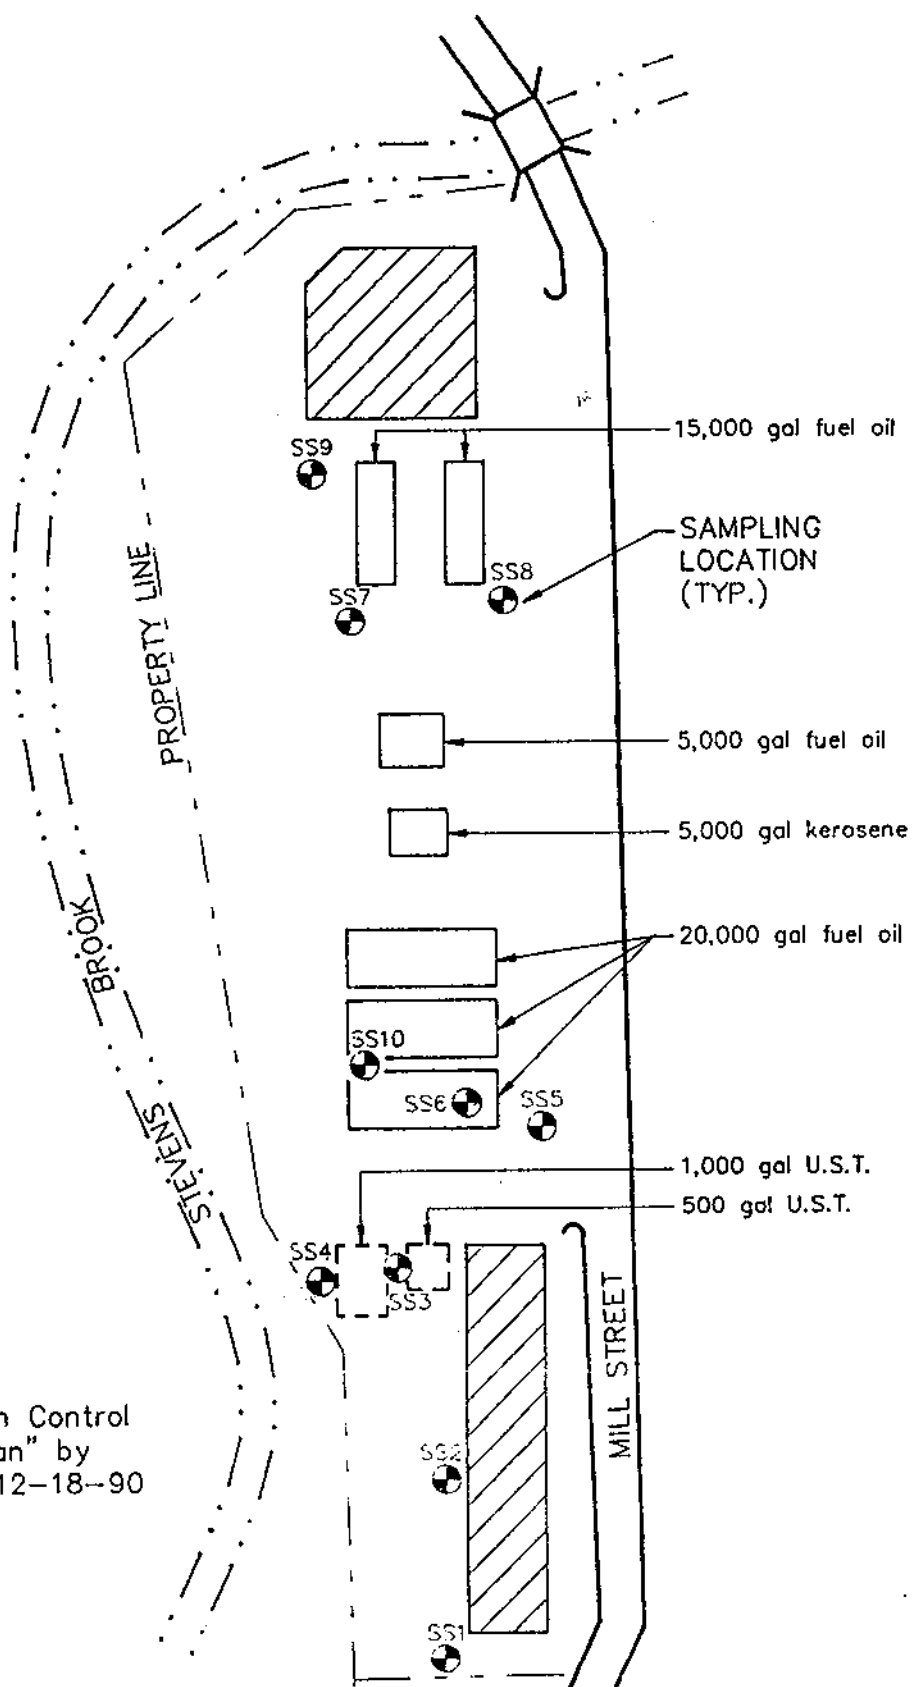
FIGURE 2 - SAMPLING LOCATION SKETCH  
CALDER & RICHARDSON SITE  
BARRE, VERMONT

During the site inspection, a total of ten soil samples and one duplicate were taken utilizing a hand auger. The sampling locations are shown in Figure 2. Chain-of-custody forms for the samples are contained in Appendix B. The samples were forwarded to Scitest Laboratory Services in Randolph, Vermont and analyzed for Total Petroleum Hydrocarbons (TPH). This analyte was chosen since it is an effective way of determining if many of the more prolific compounds suspected or known to be used on the site (fuel oil, kerosene, jet fuel, gasoline) were released to the soils. The results of these analyses are contained in Table 1 with the depth at which the samples were taken (see Appendix C).

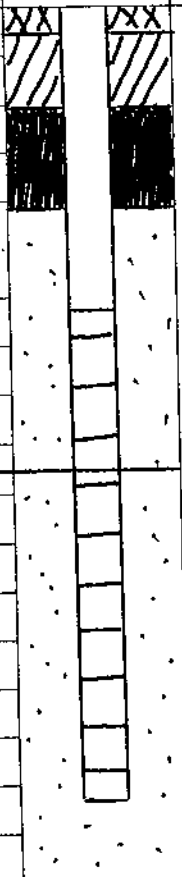
WELL/BORING NO.: TS-5	DEPTH OF WELL: 16.4 ft DEPTH OF BORING: 18 FT
PROJECT NAME: Calder & Richardson	DEPTH TO WATER: 9.6 ft
PROJECT NO.: 94171	SCREEN DIA: 2 in. DEPTH: 6.4 - 16.4 ft
INSTALL DATE: 12/20/94	SCREEN TYPE/SIZE: Sched. 40 PVC, 0.010 in. mach. slot
TSEC REP.: kjb	RISER TYPE: Sched 40 PVC
DRILLING CO.: Tri-State Drilling & Boring	RISER DIA: 2 in. DEPTH: 0.5 - 6.4 ft
DRILLING METHOD: Air Rotary	GUARD TYPE: Flush mount curb box
SAMPLING METHOD: Split spoon	RISER CAP: Expansion plug

DEPTH IN FEET	WELL PROFILE	SAMPLE DEPTH (FT)	PID (PPMV)	BLOWS/6" AND RECOVERY	SOIL DESCRIPTION AND NOTES	LEGEND
1
